# KLINGER CASE STUDY

## Offshore Asset

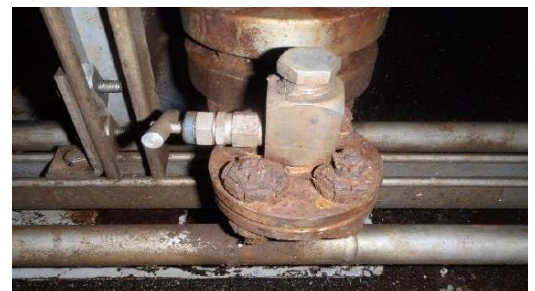
It is important that the bolts on the hydraulic line would hold until the next shutdown/maintenance, however, this couldn't be guaranteed due to corrosion on the bolts. The bolts were also situated in an area that had extremely tight access.

IMAGE SHOWING TYPICAL CORROSION ON BOLTS BEFORE REMOVAL ON 150# FLANGES

Using the KLINGER Hot Bolt Clamp, we were able to change out the corroded bolts for new bolts one by one whilst still maintaining the alignment and integrity of the flanged joints, without the requirement to flush/purge or retest the system. We supplied all the equipment and our onsite engineers held all the required flange management/bolting certification tickets. The scope was carried out in a timely manner and due to the success of the scope, our team stayed offshore to perform other hot bolting activities in order to improve the site's overall condition, saving time and money.

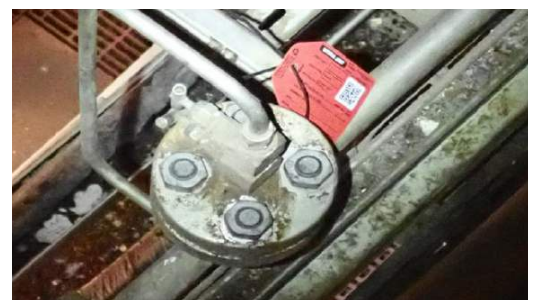
IMAGE SHOWING THE REPLACEMENT OF BOLTS FOLLOWING THE UTILISATION OF THE KLINGER FLANGE TOOL
